## DOWN IN THE LIME STREET CUTTING

Lime Street station in Liverpool was opened in 1836, connected to Edge Hill by one long tunnel. In the 40 years to 1885 the tunnel was gradually cut back and the line widened until the splendid array of bridges and tunnels to be seen today was created. The cutting was in the news during March when the collapse of a section of wall meant the temporary closure of the station until repairs had been completed.

**JOHN C. HUGHES** takes us into the cuttings and tunnels.

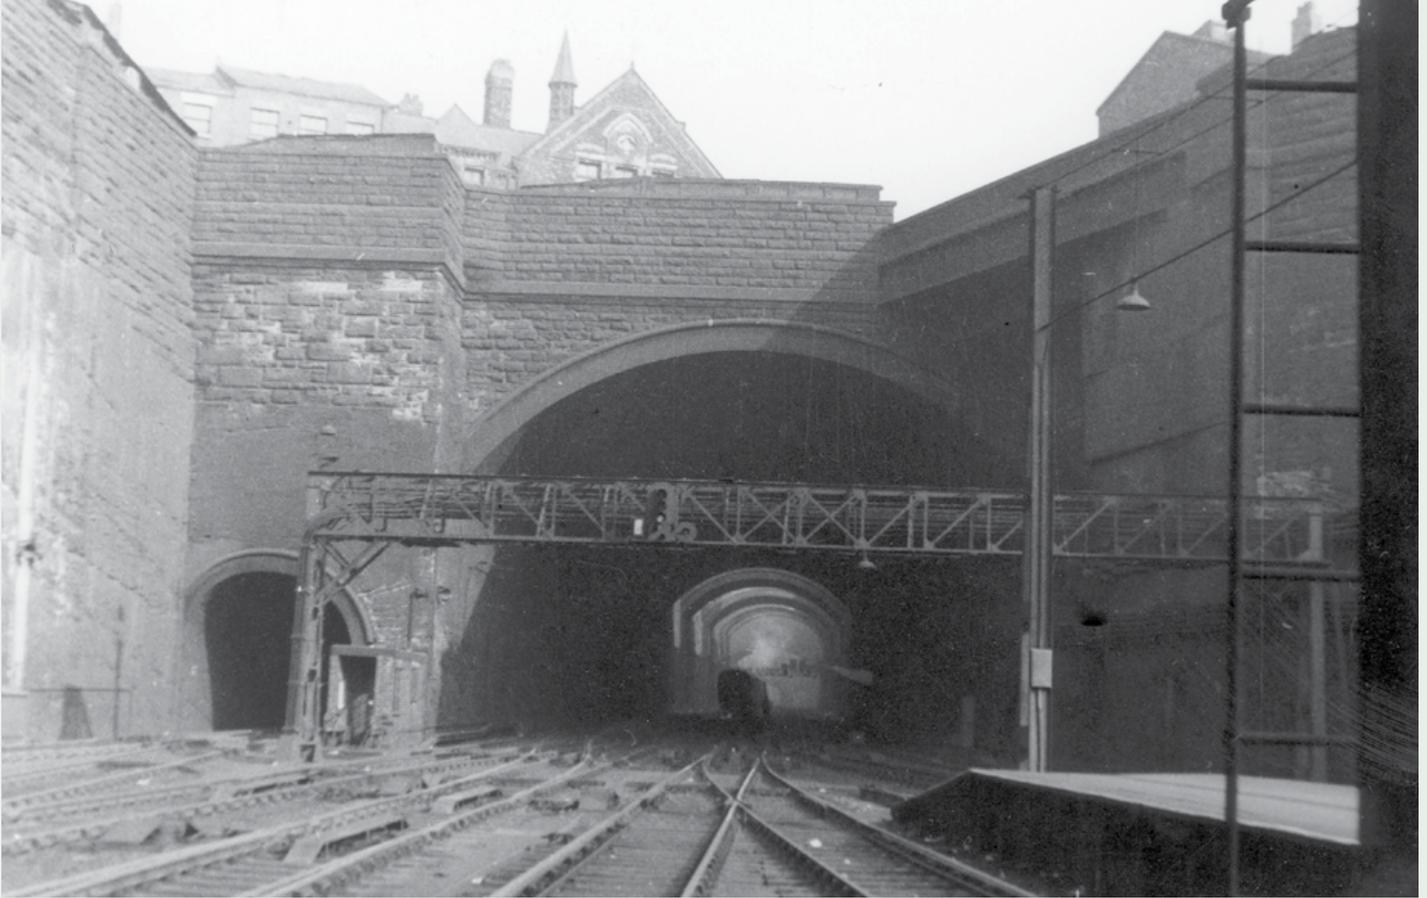
The view from the terminus shortly before the wires started to go up. The massive brickwork and girders on the right are an aberration – bedrock below and rusticated stonework above are the usual style throughout. Bricks are usually restricted to the arches and patches to cover faults in the rock. The single line tunnels on the left were an afterthought, to allow one of the four lines in the main Russell Street tunnel to be used as a shunting neck. (D. Ibbotson)

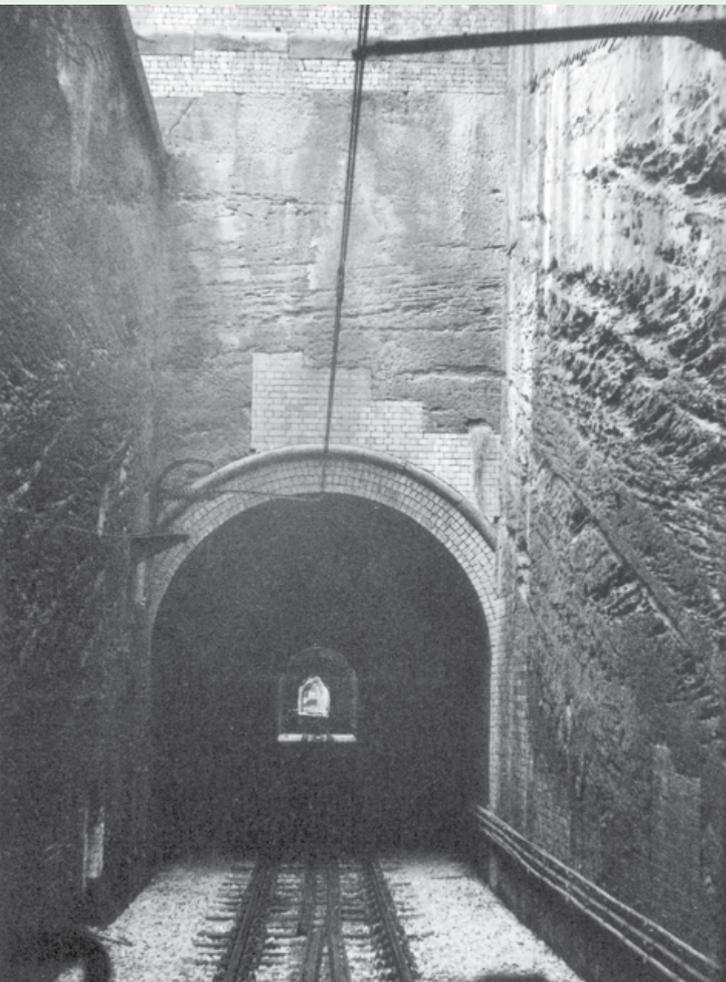
In 1903 George Whale began to introduce larger locomotives and the carriages were getting bigger as well. As some of these used the single line there was soon a rash of complaints about smoke in these tunnels. In 1908 three ventilation shafts were added to the longest of them – set at an angle so that they could vent into the higher tunnel alongside. In 1923, the newly-formed LMS decided to add five more of these openings. All the ones readily visible are from this batch. Some were given decorative brick lining, like this one, while others were just holes in the rock. (D. Ibbotson)

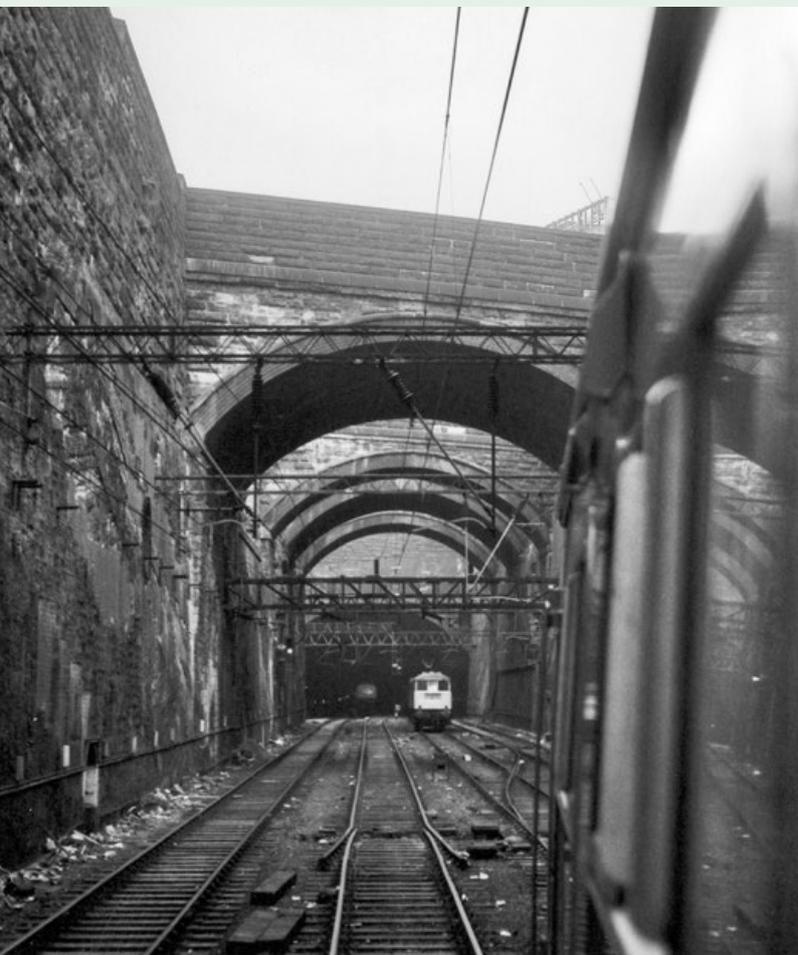
**ABOVE:** This is the four-track line alongside the single tunnels. The train I am on has just come from the down fast using the crossing behind and is continuing to the shunting neck. Any rolling stock leaving this without permission will doubtless be stopped in its tracks by the catch points, which are clearly designed to keep the runaway off the running lines to either side. The vent on the left, between St. Andrew and Gill Streets, appears to be the one in the last picture. The five-track span in the distance is Brownlow Street bridge, now with the other side closed in as mentioned below.

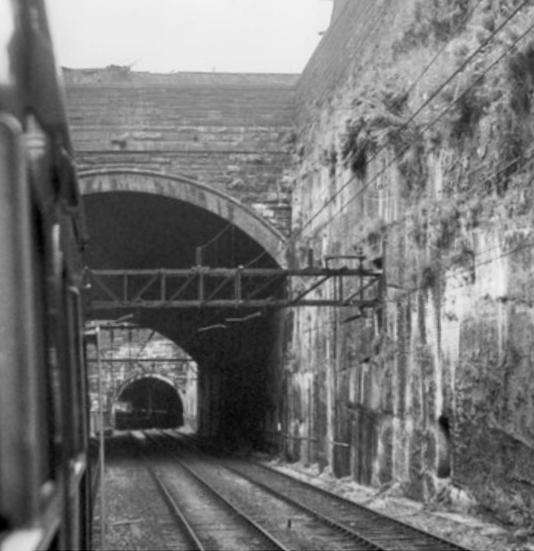
ABOVE: This is the north side of the cutting showing the Crown Street tunnels and Smithdown Lane again. The section of wall at top right is the part that collapsed on 28th February this year. An engineer interviewed on television mentioned the need to watch out for unknown tunnels; I am not sure if the brick patches here are a sign of Williamson's work, but he was certainly active a little way to the west and north. There have been similar collapses along Olive Mount cutting and the Cheshire Line's Committee's route out of Liverpool; such incidents generally follow heavy rain and the latest slip is no exception. One does wonder if it is wise to allow all that greenery to push roots into the cutting walls – just a thought. It never used to happen.

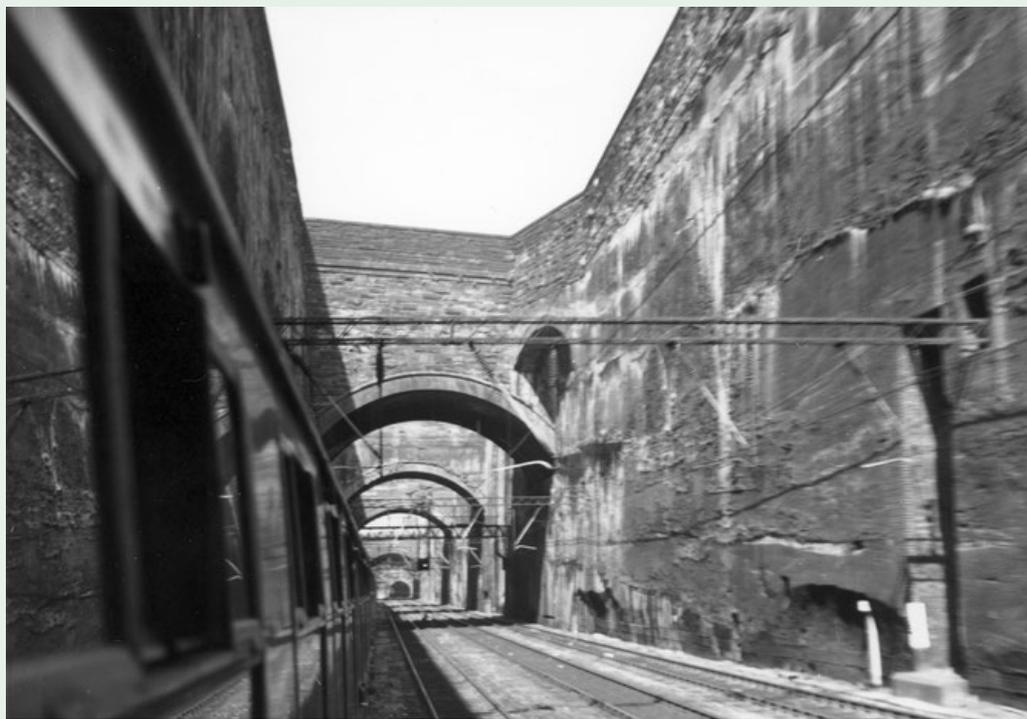
TOP, RIGHT: The main point of interest in this view is the ghost of the 1836 tunnel on the north side of the cutting. It will be noticed that the curve of the roof starts quite low down; in fact some work had to be done in enlarging the surviving parts of this tunnel before tracks could be laid with the new standard gap of six feet between them. Going east, we have now passed Mason, Highgate and Kinglake Streets. The last was joined by Nevison Street just here – hence the generous squinch arch. (D. Ibbotson)

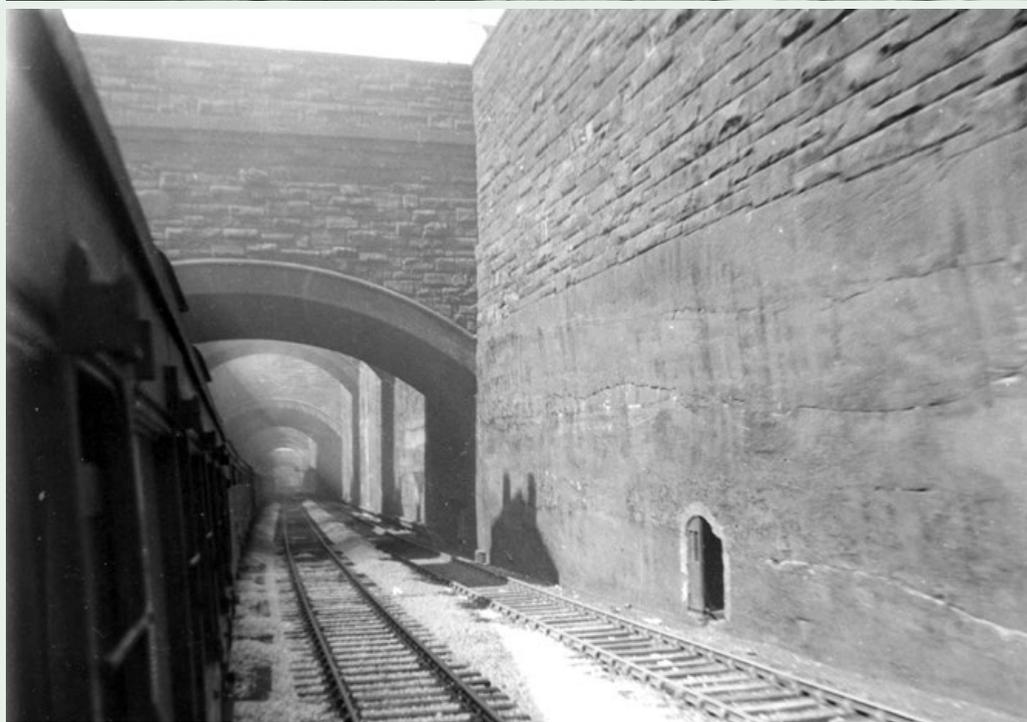
RIGHT: At last, another pre-electrification view. The cutting really did look better without wires and without weeds. We are looking west with Chatsworth Street bridge in the foreground. (D. Ibbotson)

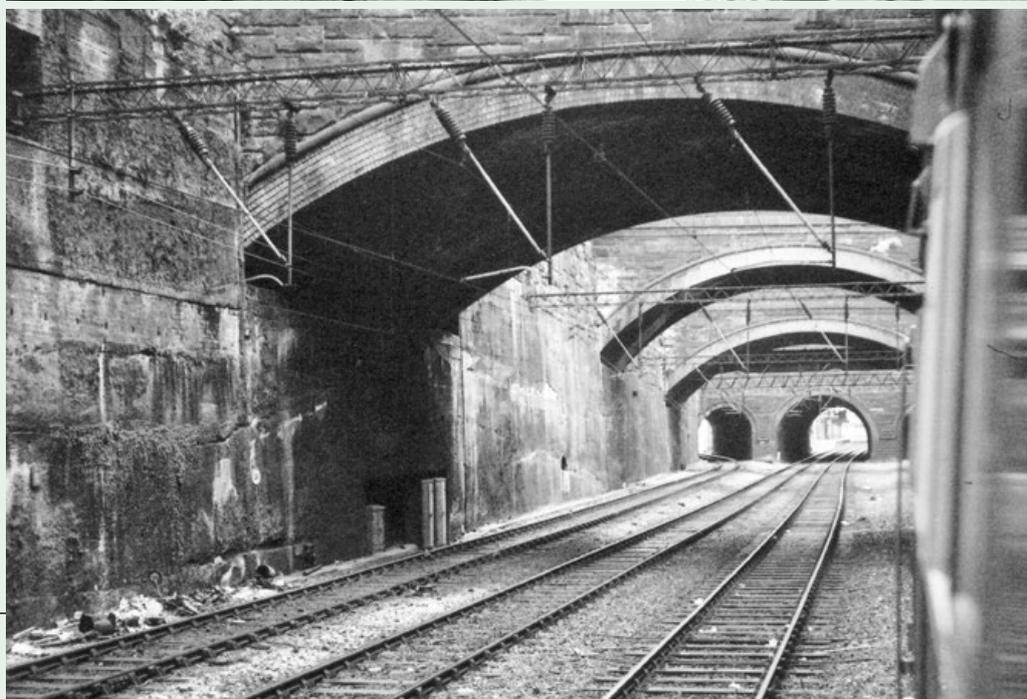
BOTTOM: Looking east under Chatsworth Street at the last stretch before Edge Hill station, visible through the third fragment of the 1836 tunnel which still has its original stone surround at the east end. With another two bridges and three tunnels to go, Chatsworth Street's bridge plate is number 26. Eric Treacy was often to be found with his back to the wall between the centre tunnel and the single track tunnel just out of sight to the right. It was a safe place and convenient to reach, but this meant that his views often show the sewer suspended under Uxbridge Street bridge – the one such straight line in the whole cutting. Of course, his views of the cutting are often spoilt by trains getting in the way as he pressed the shutter!
